Case Study

Client: Virginia Park, Virginia Water

Project Title: Conservatory Fretwork

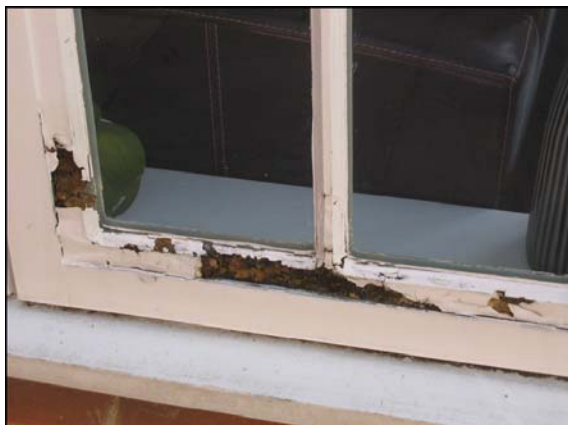
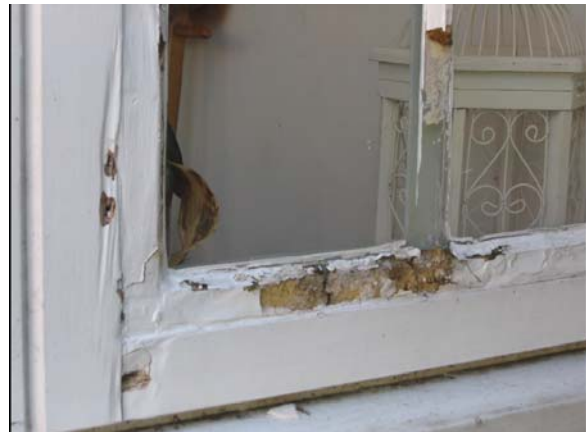
The following case study outlines the process that was undertaken upon Virginia Park's conservatories earlier this year. Our clients approached us to replace the fretwork used within the exterior design of the conservatories. The main problem with the fretwork was rot which had happened in a reasonably short space of time due to the material used: MDF. This material is not designed for exterior use and when we visited one of the homes with this problem we were shocked at how tatty it made the conservatory look.

In order for Bespoke Joinery to reproduce this fretwork accurately and in the best material for the job (Marine ply), we had to create templates for each window size. Once the templates were ready recreating the fretwork became a simple task for our skilled carpenters and joiners.

The removal of the old MDF fretwork panels was carried out as carefully as possible so not to damage the double glazed units underneath. The new panels were then stuck in place upon the glass and sealed all round the edges to help protect them. All new panels were finished with a double coat of primer to help protect the ply from future weathering.
